ADDENDUM NO. 1 New Braunfels National Airport TxDOT Project ID#2215NEWBR Issued: June 15, 2022

New Braunfels Municipal (BAZ)

05/27/2021

Inspection Results 05/27/2021 New Braunfels Municipal (BAZ)

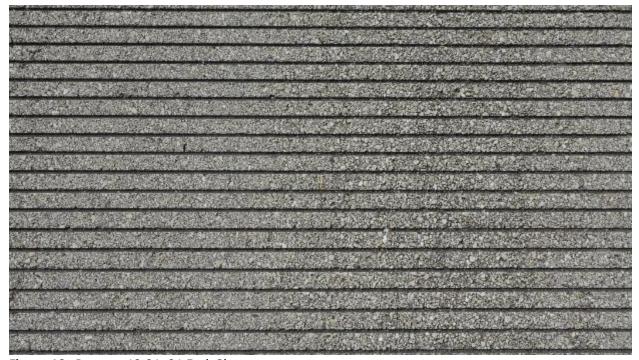
Figure 10. Runway 13-31, 31 End, Close.

The Runway 13-31 pavement at New Braunfels was overlaid in 2012 and extended in 2014. The pavement is good condition but beginning to weather and has some wide seam cracks. Figures 1-10 illustrate the extent and severity of the weathering and cracking. The runway is very strong (Table 9) and is fairly smooth (See High Speed Video). A crack and coal tar seal will improve the condition and help to extend the life of this pavement.

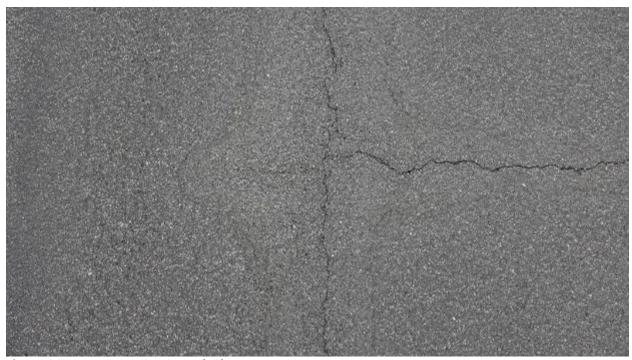
Figure 20. Runway 17-35, 35 End, Close.

Runway 17-35 was constructed in 1995 and had a very thin overlay placed in 2019. The pavement appears to not have enough binder, causing the aggregate to dislodge and creating a FOD hazard. There is a high amount of raveling and the cracks have resurfaced quickly. Many of these cracks are pumping water and material from beneath the pavement. Figures 11-20 illustrate the extent and severity of the raveling and cracking. The runway is fairly weak (Table 9) and is mostly smooth (See High Speed Video). While it might be best to reconstruct the runway, a crack and fog seal will restore the functionality. The cracks that are pumping should be routed, filled with sealant, then crack sealed again at the top of the crack for a bond between both edges of pavement. A fog seal will help hold in some of the aggregate that is beginning to dislodge.

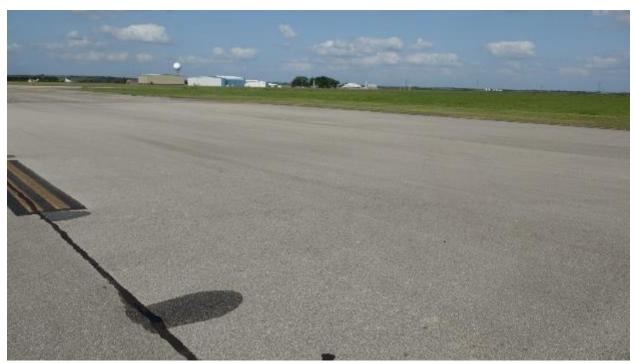
Figure 29. Apron A-31 Run Up.

NewBraun-A	A-31 Run Up	89	Weather 12,750SF, Crack 110LF	Age
NewBraun-A	A-35	69	Ravel 17,100SF, Crack 410LF	Cracks Pumping, FOD Hazard- Surface Peeling
NewBraun-A	A-35 Run Up	94	Weather 12,750SF	Age
NewBraun-A	A-B	88	Weather 40,390SF, Crack 606LF	Age
NewBraun-A	A-East	39	Weather 137,988SF, Ravel 225,800SF, Fatigue Crack 11,792SF, Crack 82,241LF	Age, Surface Peeling, Load Damage
NewBraun-A	A-Fuel	100	Nothing	Nothing
NewBraun-A	A-H2271 84	94	Crack 733LF	Good Performance
NewBraun-A	A-Hang OLD	8	Ravel 35,090SF, Patch 316SF, Fatigue Crack 8,246SF	Age, Lack of treatment
NewBraun-A	A-Park	100	Nothing	New
NewBraun-A	A-PCC	87	Linear Crack 35SL, Corner Break 10SL, JT Spall 15SL	Load Damage
NewBraun-A	A-T Hang A	77	Weather 131,331SF, Crack 6,435LF	Checking, Wide cracks
NewBraun-A	A-T Hang B	69	Ravel 31,676SF, Crack 594LF	Surface Peeling
NewBraun-A	A-Term	88	Weather 197,353SF, Crack 3,035LF	Checking
NewBraun-T	Т-АВС	89	Weather 99,100SF, Crack 1,239LF	Good Performance

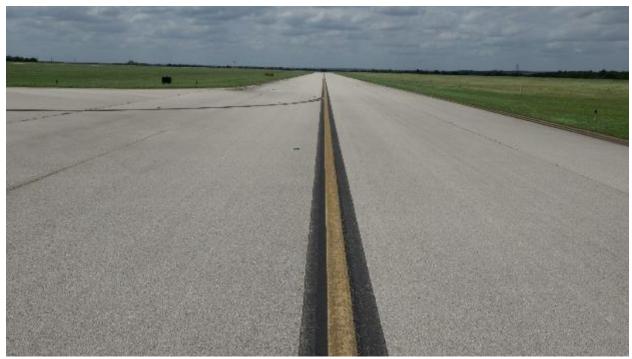
Figure 57. Taxiway T-A C G.

NewBraun-T	T-A C G	74	Weather 65,100SF, Ravel 260SF, Fatigue Crack 87SF, Crack 3,711LF	Load Damage
NewBraun-T	T-A East	85	Weather 137,050SF, Fatigue Crack 55SF, Crack 3,381LF	Load Damage
NewBraun-T	T-A F G		Weather 24,762SF, Crack 495LF	Age
NewBraun-T	T-B	87	Weather 35, 138SF, Crack 773LF	Age
NewBraun-T	T-C	85	Weather 34,040SF, Crack 749LF	Age
NewBraun-T	T-D	75	Weather 33,332SF, Ravel 33SF, Crack 1,533LF	Age
NewBraun-T	T-E 1735	75	Weather 89,973SF, Ravel 22SF, Crack 1,327LF	Age
NewBraun-T	T-E East	59	Weather 25,168SF, Ravel 164SF, Fatigue Crack 13SF, Crack 1,459LF	Age, Edge Cracks, Load Damage
NewBraun-T	T-F	68	Weather 176,896SF, Patch 758SF, Crack 22,542LF	Age, Edge Cracks
NewBraun-T		76	Weather 100,902SF, Crack 7,144LF	Age, Edge Cracks
NewBraun-T		71	Weather 58,490SF, Ravel 585SF, Crack 2,486LF	Age, Edge Damage

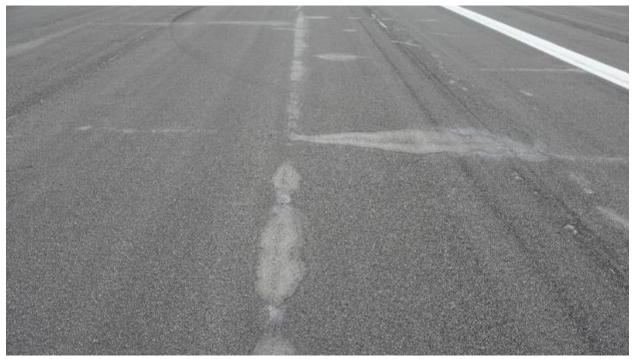
Figure 66. RW 17-35. Pumping Cracks

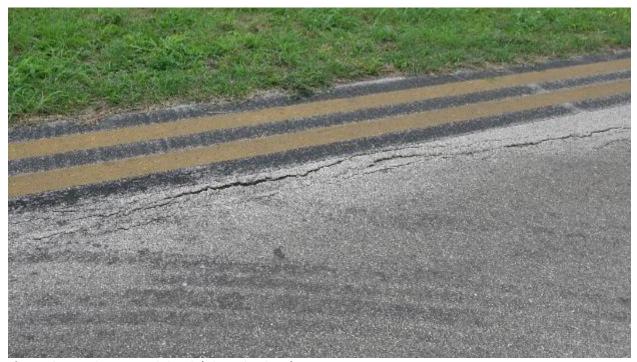
Figure 67. Taxiway, T-A C G. High Severity Crack.

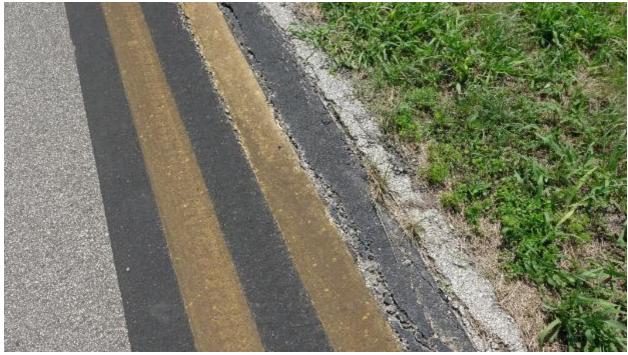
Figure 68. Taxiway, T-E East. Edge Damage

NewBraun-A	A-Fuel	1/31/2011	100	Good	Nothing
NewBraun-A	A-H2271 84	7/2/2015	94	Good	Crackseal
NewBraun-A	A-Hang OLD	3/21/1994	8	Poor	Reconstruct
NewBraun-A	A-Park	7/1/2019	100	Good	Wait for Coaltar seal
NewBraun-A	A-PCC	1/31/2011	87	Good	Patch+Crackseal
NewBraun-A	A-T Hang A	2/1/2012	77	Good	Crackseal
NewBraun-A	A-T Hang B	2/1/2012	69	Fair	Crack seal+Coal tar seal
NewBraun-A	A-Term	1/1/2014	88	Good	Crackseal
NewBraun-T	T-A B C	12/1/2014	89	Good	Crack+Coaltar seal
NewBraun-T	T-A C G	7/1/2012	74	Good	Patch+Crack seal+Coal tar seal
NewBraun-T	T-A East	7/1/2012	85	Good	Patch+Crack seal+Coal tar seal
NewBraun-T	T-A F G	12/1/2014	88	Good	Crack+Coaltar seal
NewBraun-T	T-B	12/1/2014	87	Good	Crack+Coaltar seal
NewBraun-T	T-C	12/1/2014	85	Good	Crack+Coaltar seal
NewBraun-T	T-D	7/1/2012	75	Good	Crack+Coaltar seal
NewBraun-T	T-E 1735	9/11/2003	75	Good	Patch+Crackseal+Coaltarseal
NewBraun-T	T-E East	7/1/2012	59	Fair	Patch+Crackseal+Coaltarseal
