ADDENDUM NO. 1 New Braunfels National Airport TxDOT Project ID#2215NEWBR Issued: June 15, 2022

New Braunfels Municipal (BAZ)

05/27/2021

Inspection Results 05/27/2021 New Braunfels Municipal (BAZ)

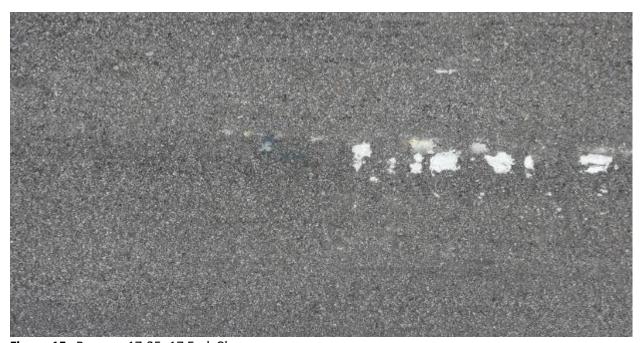
Figure 15. Runway 17-35, 17 End, Close.

Runway 17-35 was constructed in 1995 and had a very thin overlay placed in 2019. The pavement appears to not have enough binder, causing the aggregate to dislodge and creating a FOD hazard. There is a high amount of raveling and the cracks have resurfaced quickly. Many of these cracks are pumping water and material from beneath the pavement. Figures 11-20 illustrate the extent and severity of the raveling and cracking. The runway is fairly weak (Table 9) and is mostly smooth (See High Speed Video). While it might be best to reconstruct the runway, a crack and fog seal will restore the functionality. The cracks that are pumping should be routed, filled with sealant, then crack sealed again at the top of the crack for a bond between both edges of pavement. A fog seal will help hold in some of the aggregate that is beginning to dislodge.

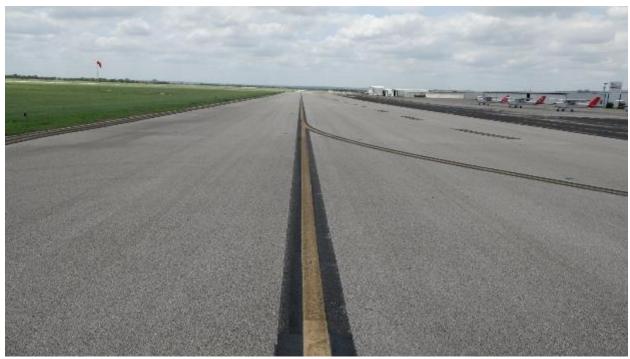
Figure 59. Taxiway T-A East.

NewBraun-T	T-A C G	74	Weather 65,100SF, Ravel 260SF, Fatigue Crack 87SF, Crack 3,711LF	Load Damage
NewBraun-T	T-A East	85	Weather 137,050SF, Fatigue Crack 55SF, Crack 3,381LF	Load Damage
NewBraun-T	T-A F G		Weather 24,762SF, Crack 495LF	Age
NewBraun-T	T-B	87	Weather 35, 138SF, Crack 773LF	Age
NewBraun-T	T-C	85	Weather 34,040SF, Crack 749LF	Age
NewBraun-T	T-D	75	Weather 33,332SF, Ravel 33SF, Crack 1,533LF	Age
NewBraun-T	T-E 1735	75	Weather 89,973SF, Ravel 22SF, Crack 1,327LF	Age
NewBraun-T	T-E East	59	Weather 25,168SF, Ravel 164SF, Fatigue Crack 13SF, Crack 1,459LF	Age, Edge Cracks, Load Damage
NewBraun-T	T-F	68	Weather 176,896SF, Patch 758SF, Crack 22,542LF	Age, Edge Cracks
NewBraun-T		76	Weather 100,902SF, Crack 7,144LF	Age, Edge Cracks
NewBraun-T		71	Weather 58,490SF, Ravel 585SF, Crack 2,486LF	Age, Edge Damage

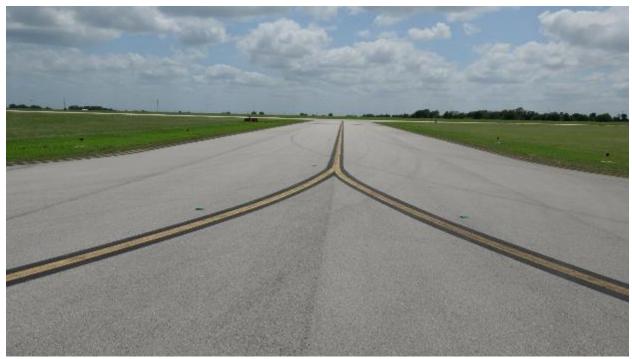
Figure 65. Taxiway T-C.

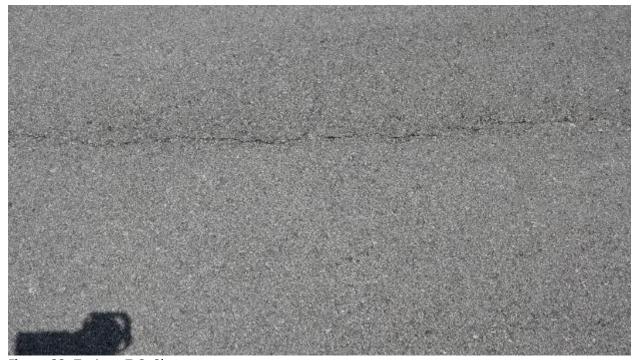
Figure 66. Taxiway T-C, Close.

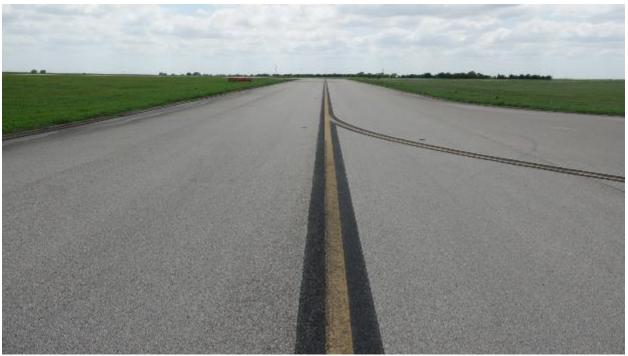
Figure 67. Taxiway T-D.

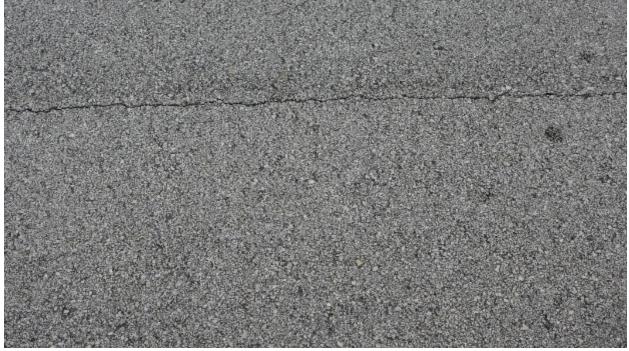
Figure 68. Taxiway T-D, Close.

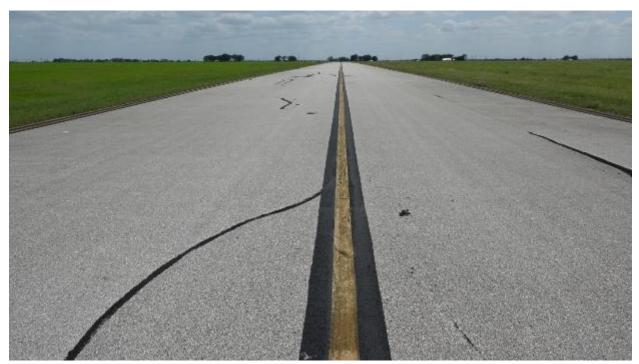
Figure 69. Taxiway T-E 1735.

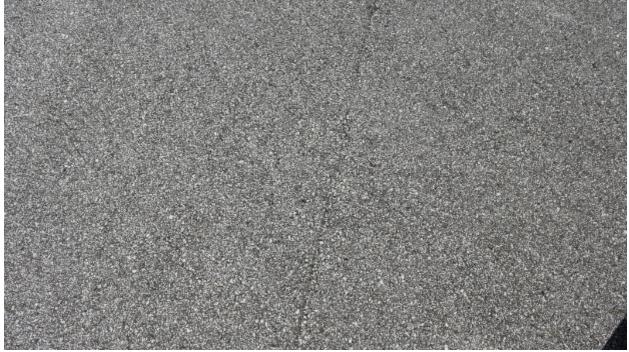
Figure 70. Taxiway T-E 1735, Close.

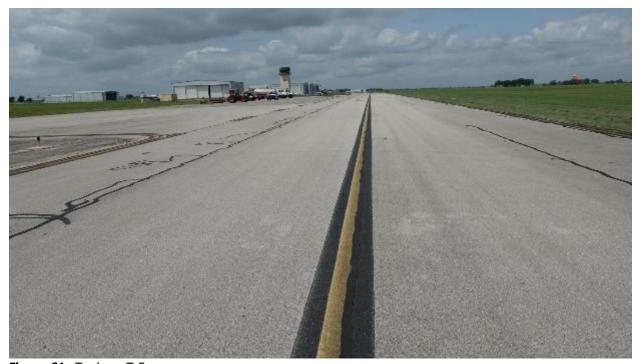
Figure 61. Taxiway T-F.

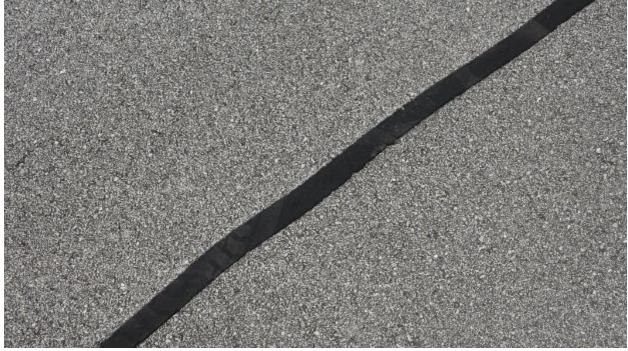
Figure 62. Taxiway T-F, Close.

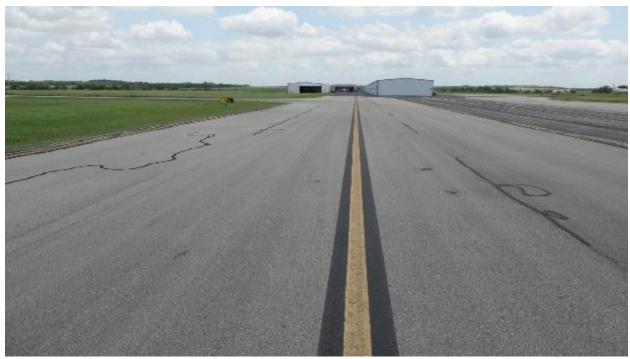
Figure 61. Taxiway T-F 31 A.

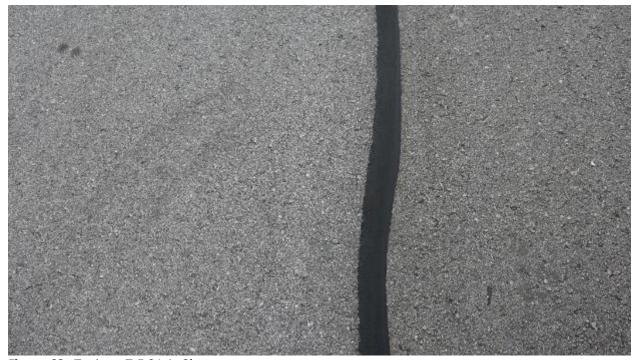
Figure 62. Taxiway T-F 31 A, Close.

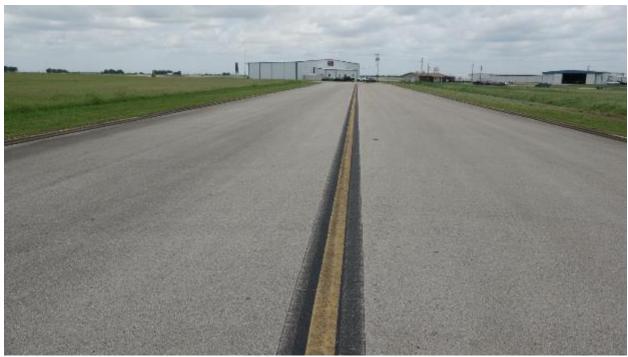
Figure 61. Taxiway T-G.

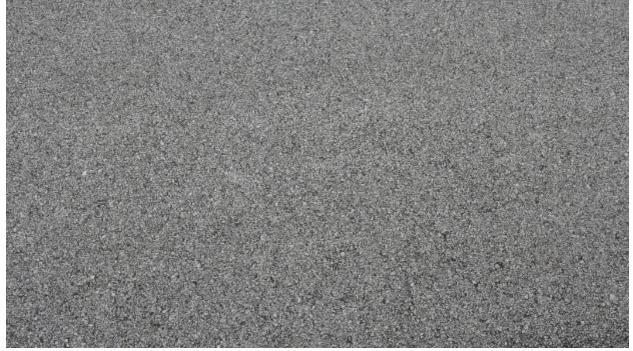
Figure 62. Taxiway T-G, Close.
